Inspection Report No: 4428

Client Name: Kasamo Pty Ltd
Property Address: 488 Pacific Highway, Belmont.

The Standard Property Report (Except ACT) Complies with Australian Standard
AS 4349.1- 2007 Inspection of Buildings Part 1: Pre-Purchase Inspections –
Residential Buildings

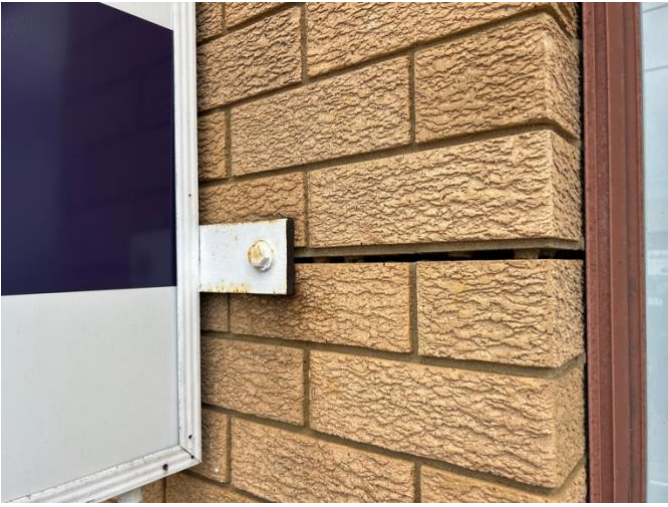
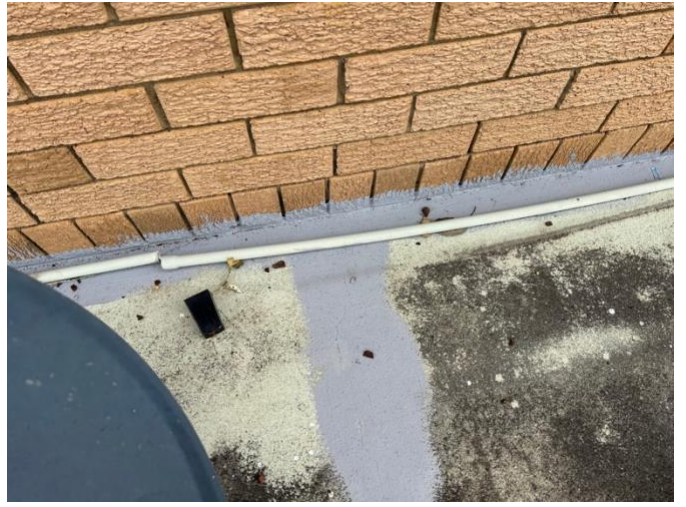
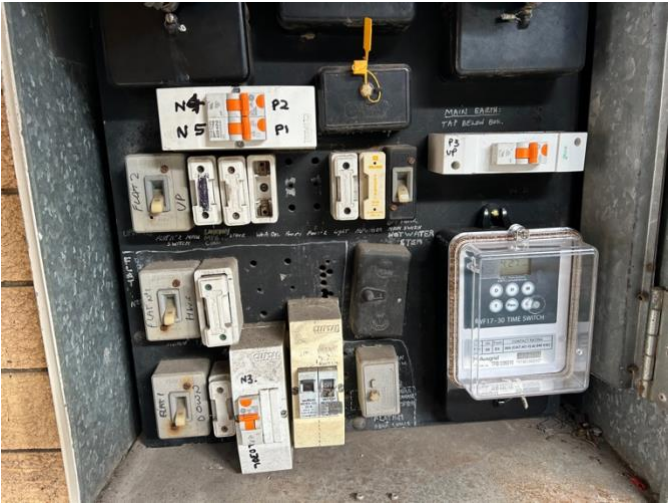
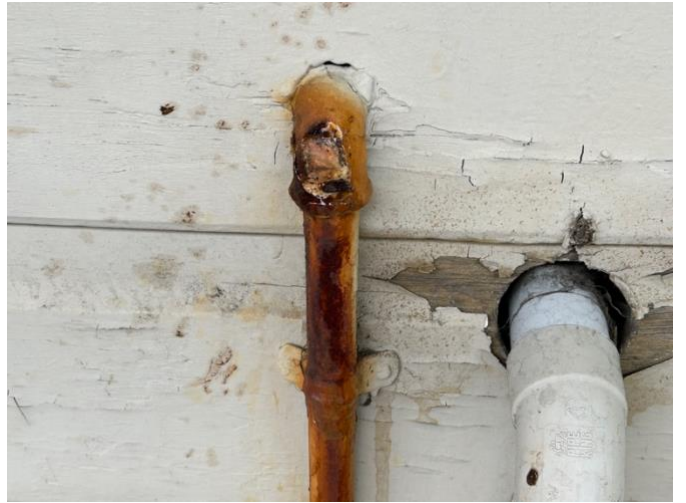
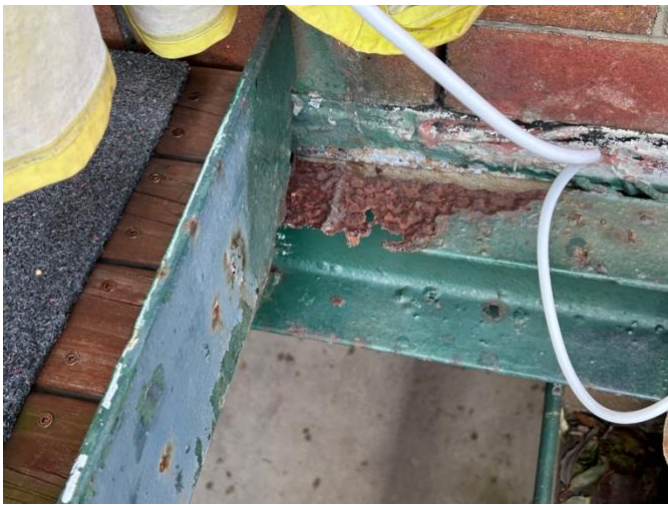
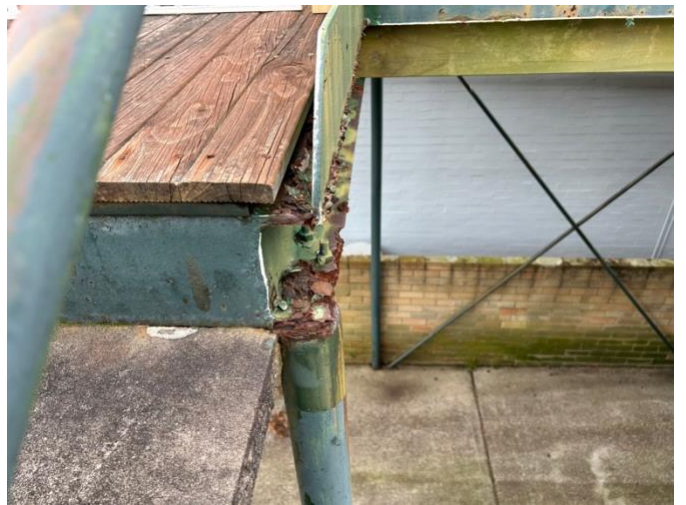
- Minor cracking noted in the cantilevered concrete awning (typical).
- Water ingress is occurring into the Mobile repair shop adjacent the awning/building junction. Sealant/waterproofing repairs recommended ASAP. (Photo page 7)
- Prep and painting recommended to the barge/fascia timbers.
- Minor to significant cracking noted in the upper level brickwork joints due to corroded sign fixings. (Photo page 7)

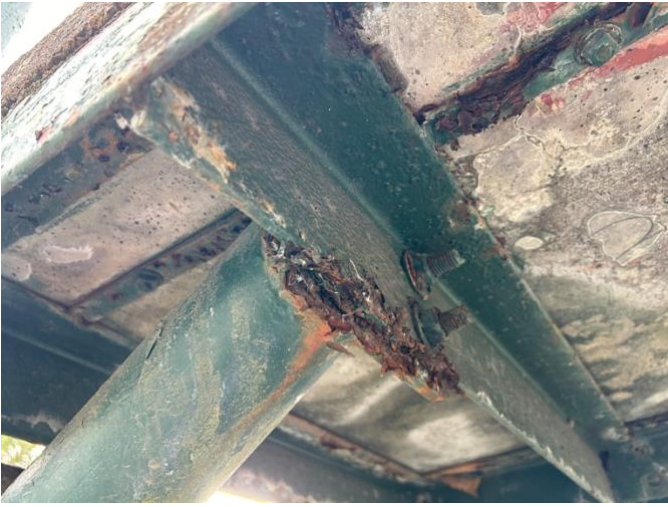
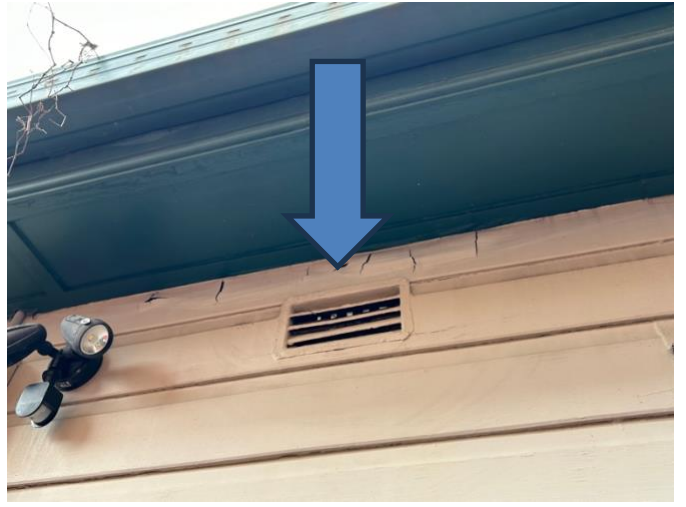
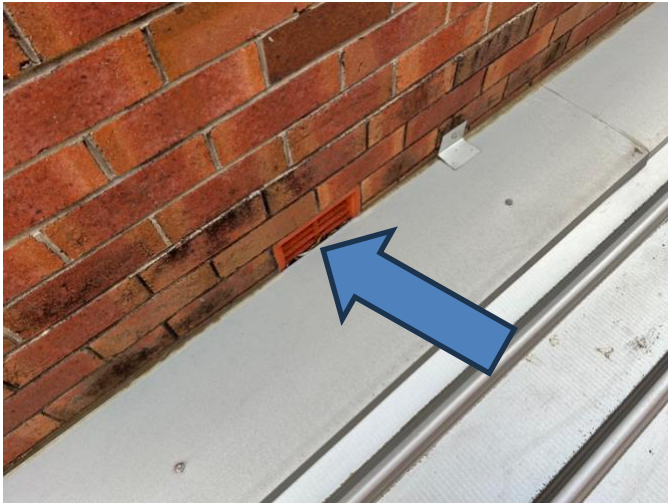
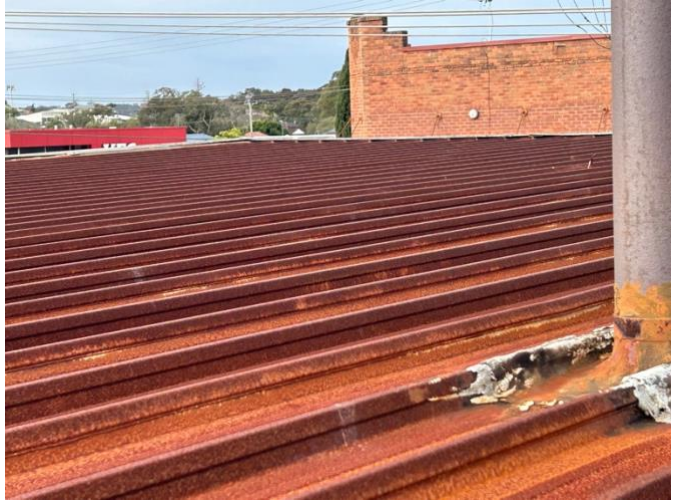
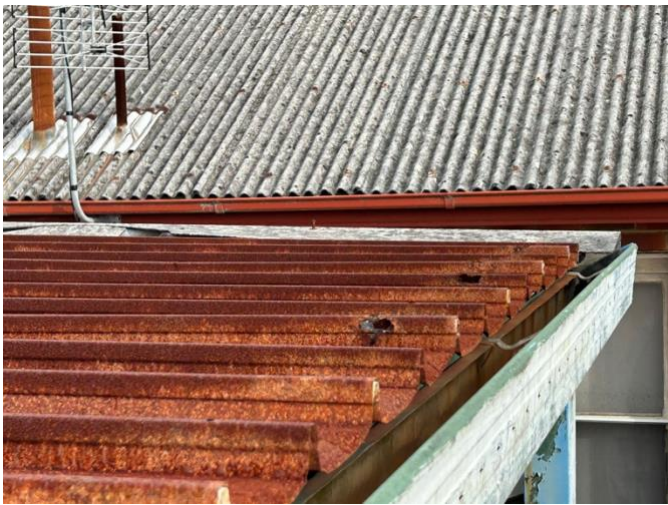
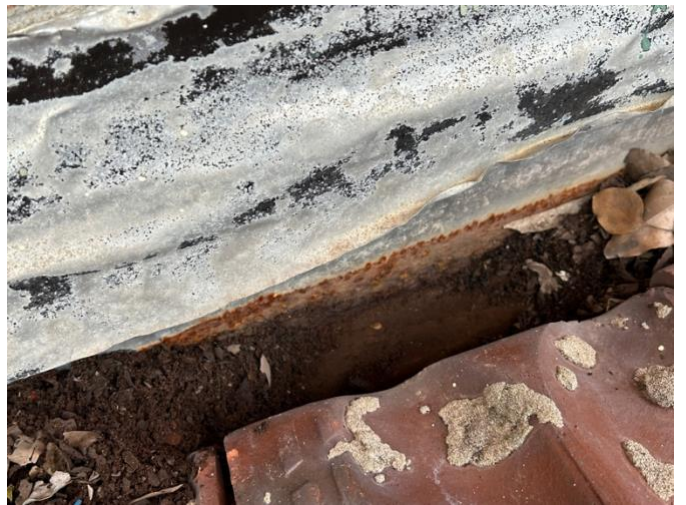
- Significant decay noted to the base of the shiplap infill boards.
- Main electrical meter box noted. Sub-boards located in shop interiors. We recommend a licensed electrician inspect for future reference. (Photo page 7)
- Extensive corrosion noted to the walkway and stair framing as per the summary. (Photos page 7 & 8)
- One damaged decking board requires replacement on the upper walkway.
- Extensive spalling noted to unit 1 step tread. Repair asap to prevent trip hazards.
- Dislodged surcharge gully requires reinstating into position.
- Cement/sand sealing required at the waste pipe/sewer junction to prevent odours.
- Extensive corrosion noted to the galvanized water pipe, including minor water escape as per the summary. (Photo page 8)

- Extensive corrosion noted to the upper roof sheets, including damaged fibro asbestos barge capping. (Photos page 8)
- Extensive corrosion and damage to the rear flashings as per the summary. (Photo page 8)
- Sealant repairs required adjacent the southern elevation carport/building junction wall cavity vent to prevent water ingress to the Dog Grooming ceiling. (Photo page 8)
- Blocked gutter noted on the southern elevation. Cleaning required. (Photo page 8)

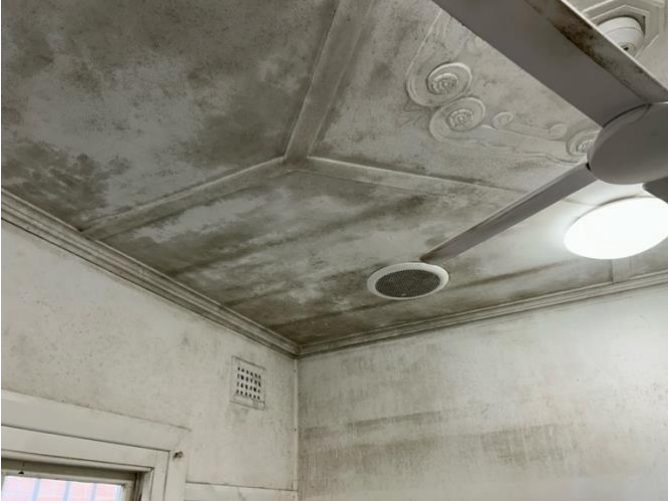
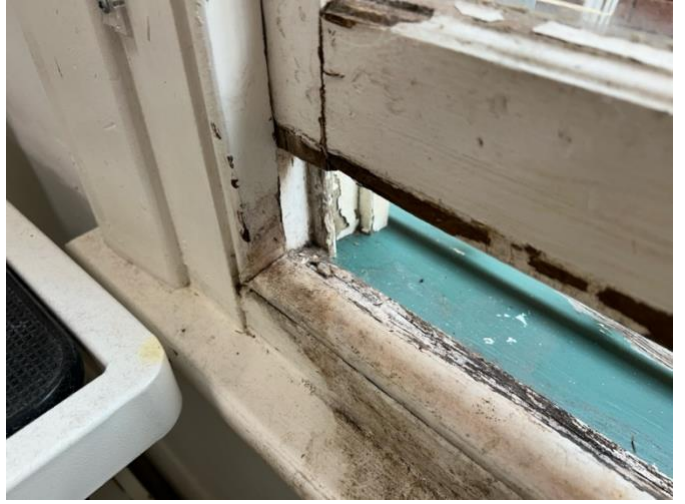
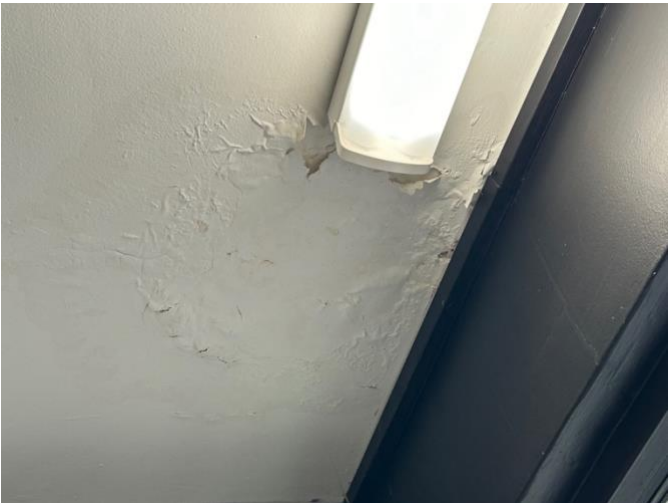
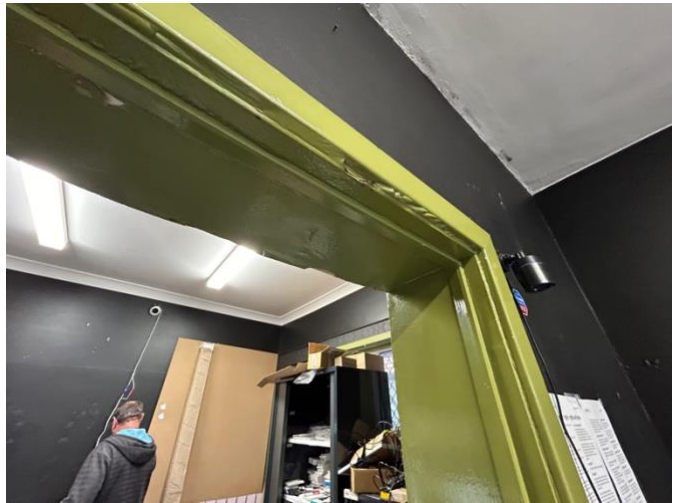
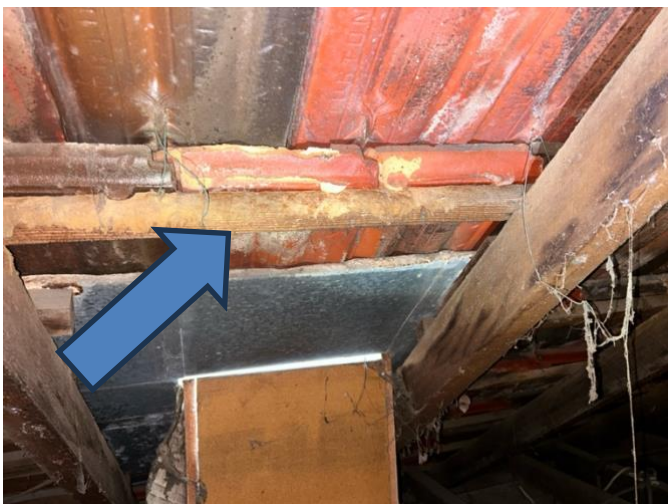
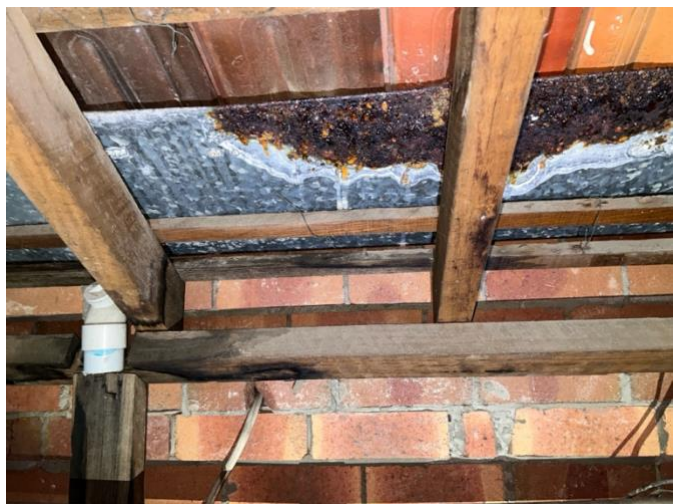
- Extensive heavy mould noted to the wall and ceiling linings. Cleaning/removal recommended asap. (Photo page 12)
- Minor decay noted to the window frames and sashes. Prep and painting recommended in the short term. (Photo page 12)
- 80 Electric HWS; date of manufacture 06/18.

- Water entry noted via front awning as per the summary. (Photo page 12)
- Water damage noted to passage door frame via the adjacent defective flashings as per the summary. (Photo page 12)
- Minor cracking noted to the concrete suspended ceiling adjacent the perimeter wall junctions (typical).
- Electrical sub-board; RCD switches protect selected power circuits only.

- The roof frame appear generally true and adequately braced.
- Areas of significant delignification to the tile battens via moisture ingress from tiles and fretting as per the summary. (Photo page 12)
- No ceiling batts fitted.
- No sarking fitted under the roof tiles.
- Corroded flashings noted at the building junctions. (Photo page 12)

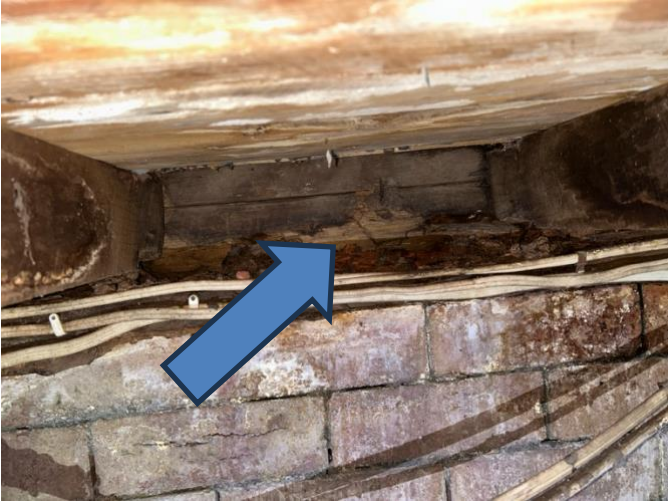
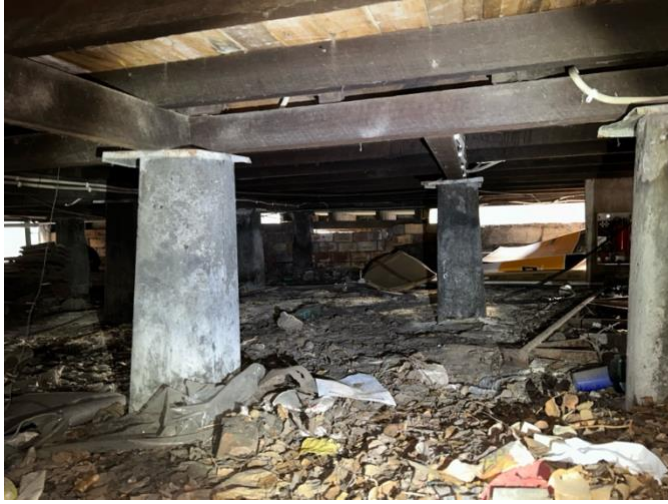
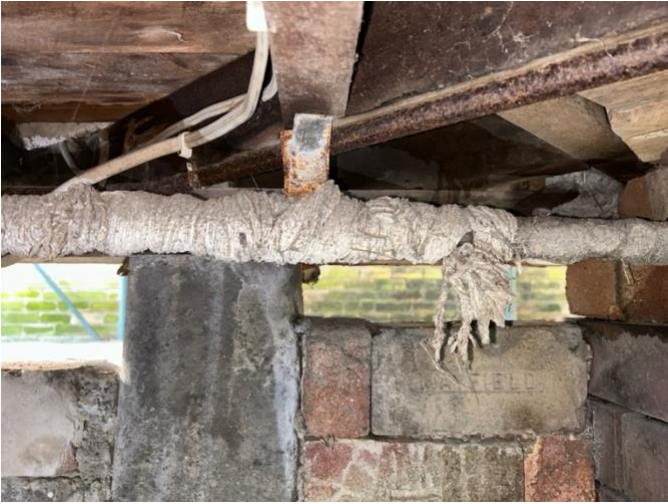
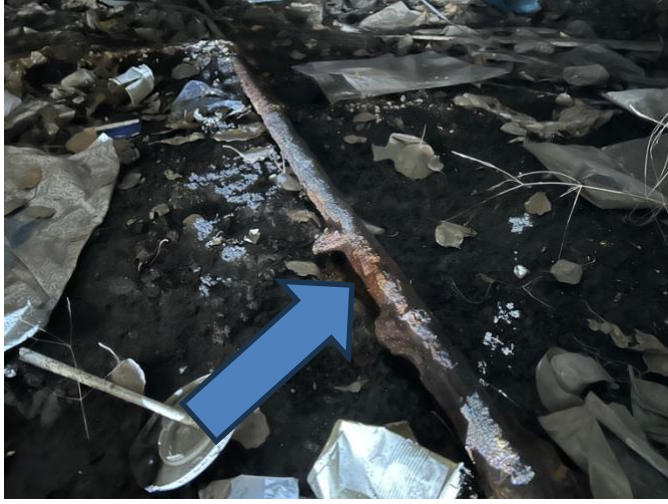
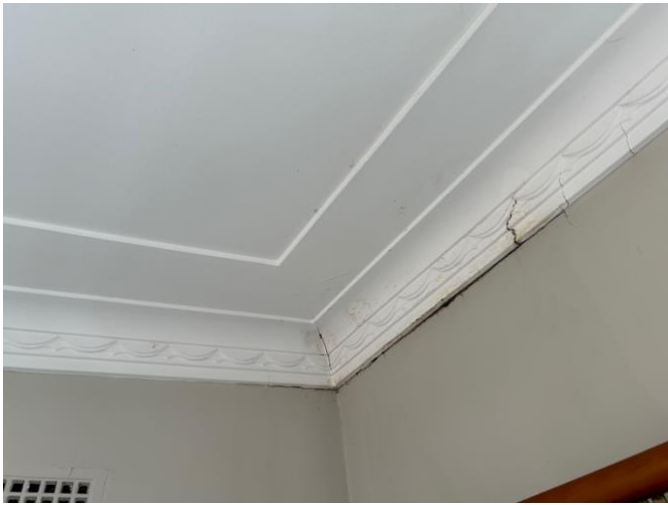
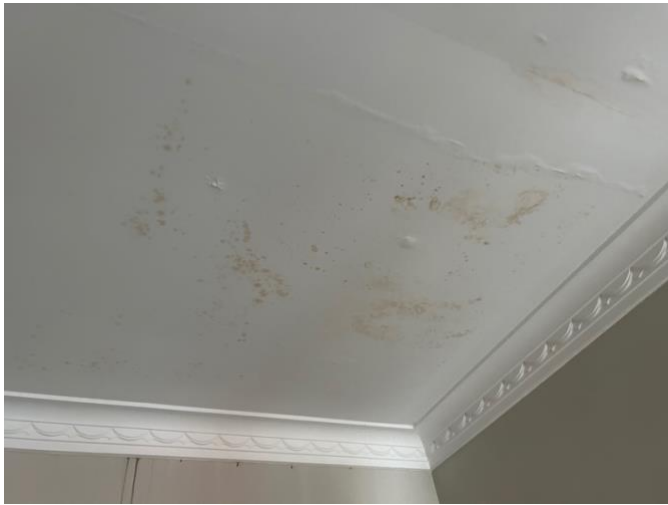
- Water damage noted to the ceiling lining adjacent the NE corner via roof sheet corrosion/defective capping. (Photo page 13)
- Minor cracking noted to the ceiling lining.
- Window sash seal/roller repairs recommended.

- Window sash seal/roller repairs recommended.
- Water damage/staining noted to the ceiling lining adjacent the NW corner via roof sheet corrosion. (Photo page 13)

- Bearers and joists appear in generally sound condition. (Photo page 13)
- Areas of termite damage noted as per the summary. (Photo page 13)
- Areas of minor differential pier settlement noted (typical). (Photo page 13)
- Pier caps appeared in generally serviceable condition despite minor to significant degrees of corrosion.
- Generally dry sub-floor soils. (Photo page 13)
- Adequate ventilation.
- Sections of corroded water pipe as per the summary. (Photo page 13)
- Asbestos lagging noted around hot water pipe. Treat as per 'Worksafe' Guidelines. (Photo page 13)

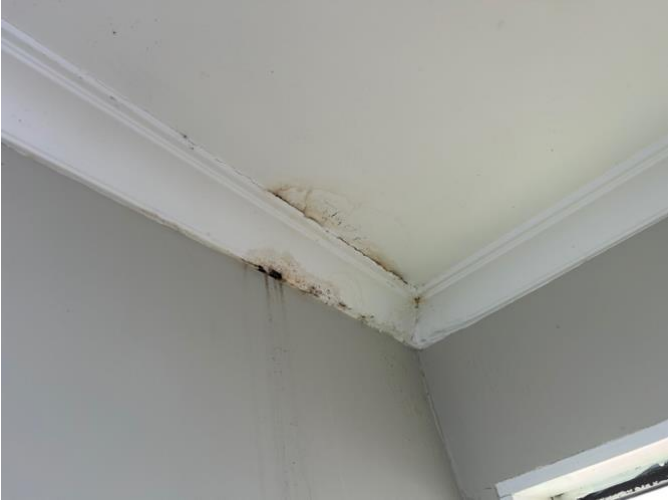
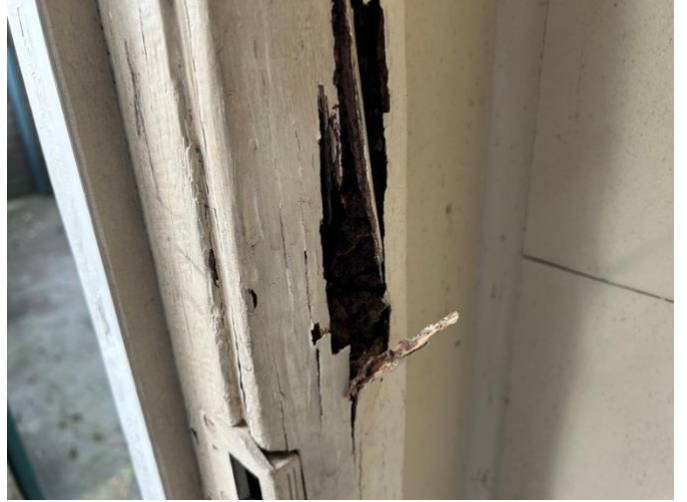
- Areas of termite damage noted in storage area of unit 2. (See Pest Report) (Photo page 14)
- Weatherboard repairs noted on the southern elevation due to decay and termite damage.
- WC is serviceable.
- Downpipe repairs required adjacent the gutter outlet and discharge outlet.

- Water damage/staining noted to the ceiling lining adjacent the NW corner via roof sheet corrosion. (Photo page 14)
- No door fitted to shower screen.
