Inspection Report

Allround Pest Management

488 Pacific Highway, Belmont, NSW, 2280

Report/Agreement #	31072405223236
Inspection Date:	30 Jul 2024
Inspection Time:	02:30 PM

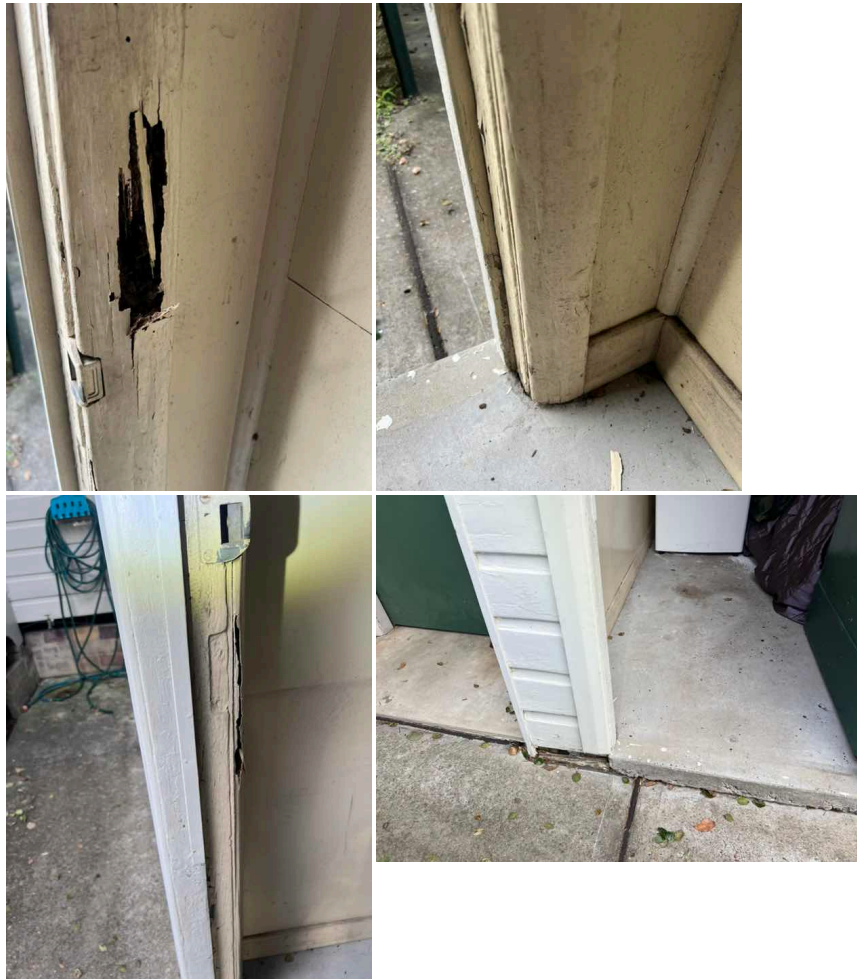
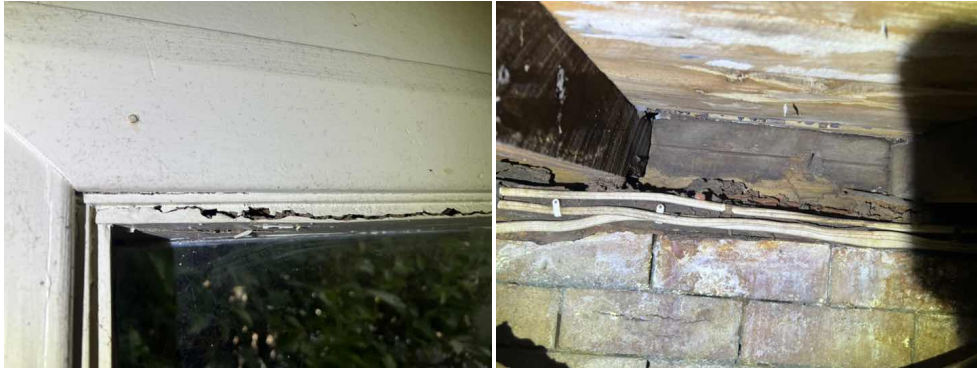
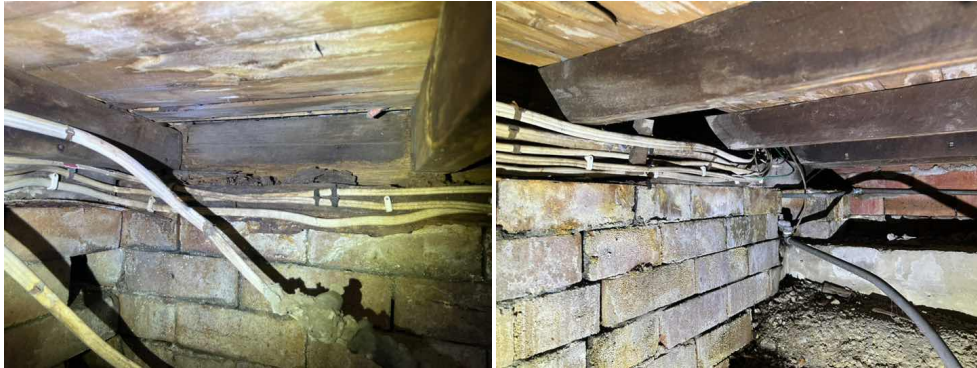
Yes, termite damage was found in the following

Sub floor timber

Outdoor storage sheds and toilets

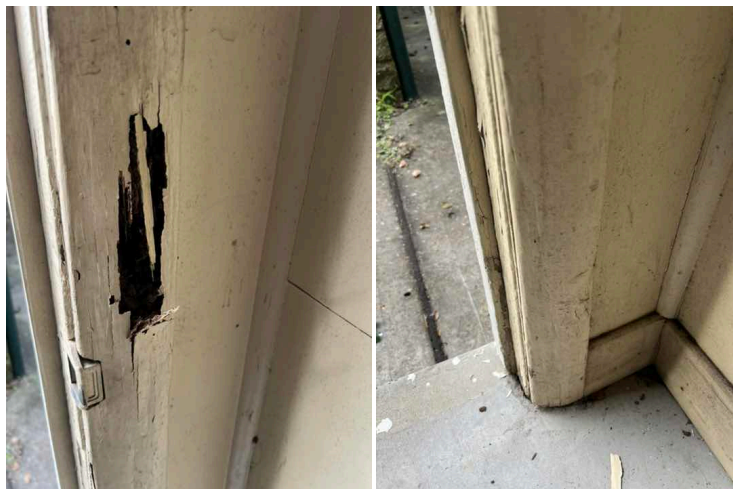
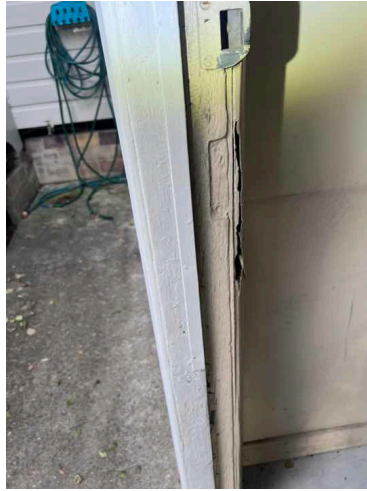
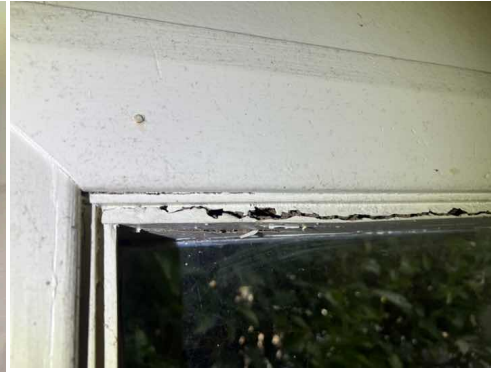
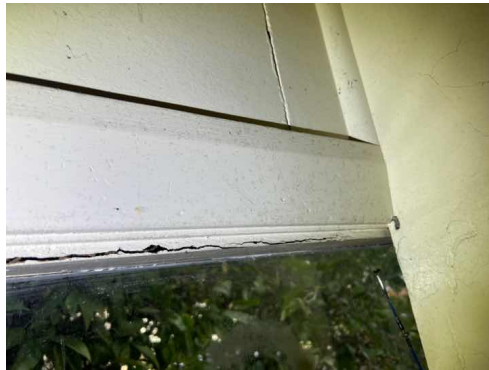
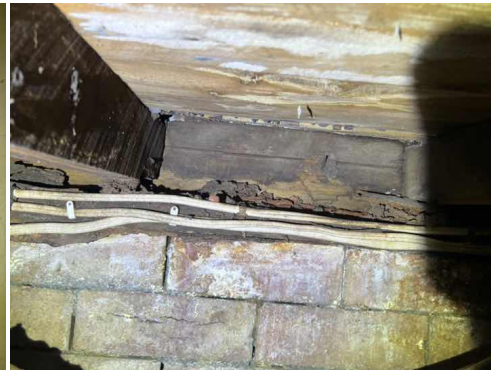
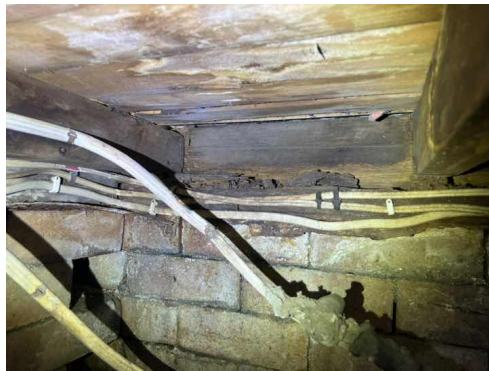
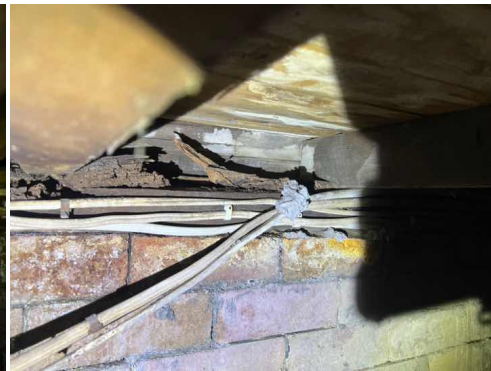
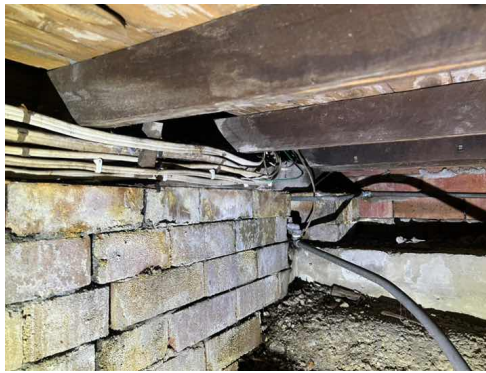
Termite workings found in outdoor toilets and laundry and subfloor timbers

Where visual evidence of termite workings and/or damage is reported above, but no live termites were present at the time of inspection, you must realize that it is possible that termites are still active in the immediate vicinity and the termites may continue to cause further damage. It is not possible, without benefit of further investigation and a number of inspections over a period of time, to ascertain whether any infestation is active or inactive. Active termites may simply have not been present at the time of inspection due to a prior disturbance, climatic conditions, or they may have been utilizing an alternative feeding source. Continued, regular, inspections are essential. Unless written evidence of a termite protection program in accord with "Australian Standard 3660" with ongoing inspections is provided, you must arrange for a treatment in accord with "Australian Standard 3660" to be carried out immediately to reduce the risk of further attack.

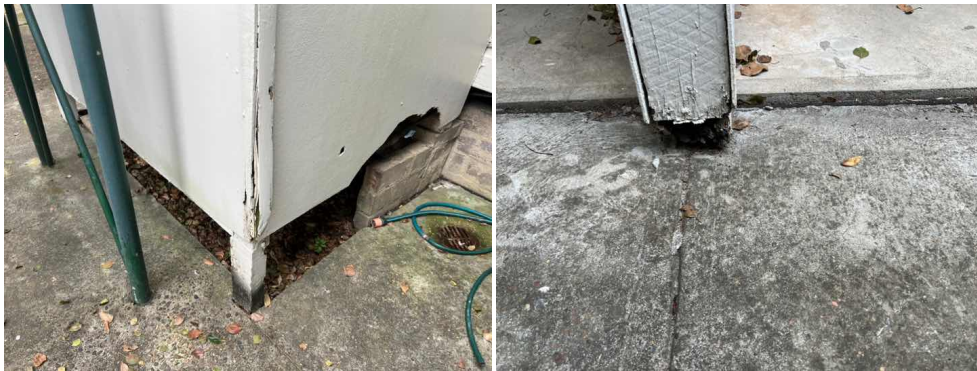
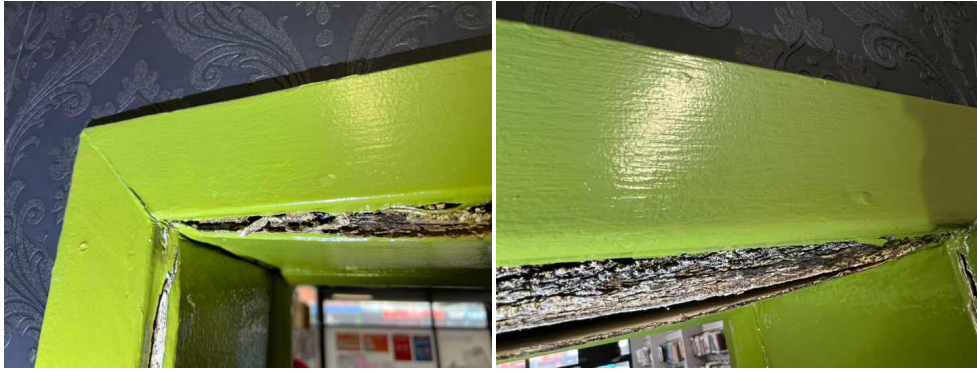
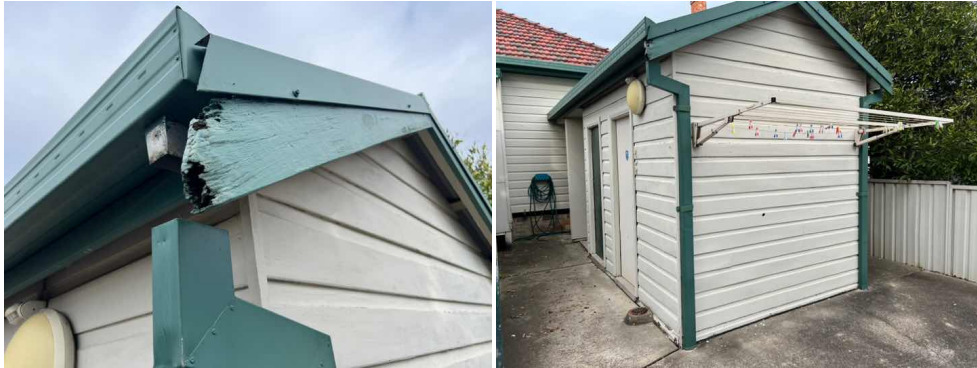
Subfloor Timbers ,

Interior door frame

Moderate Damage

Areas of moderate decay will require sections of timber to be replaced. Where there is severe fungal decay the entire affected timber member should be replaced, preferably with treated hardwood.

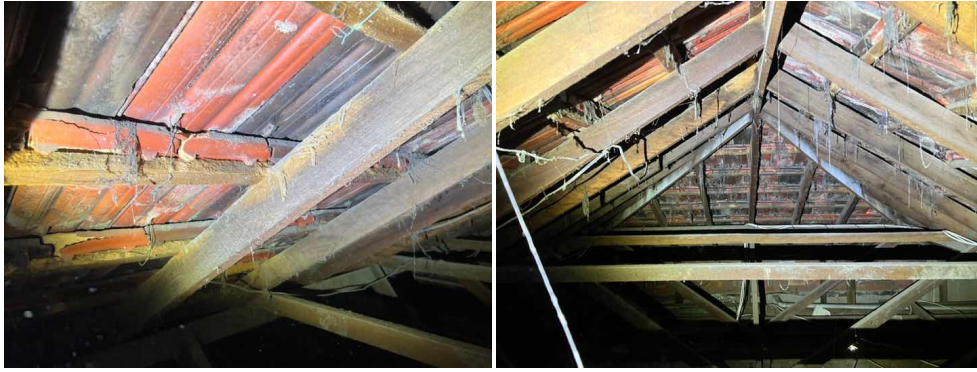
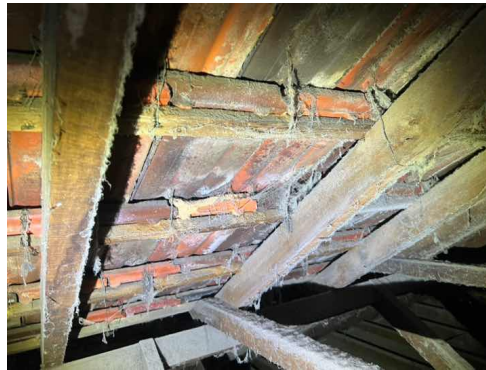
Yes. Chemical delignification was observed to roofing timbers.

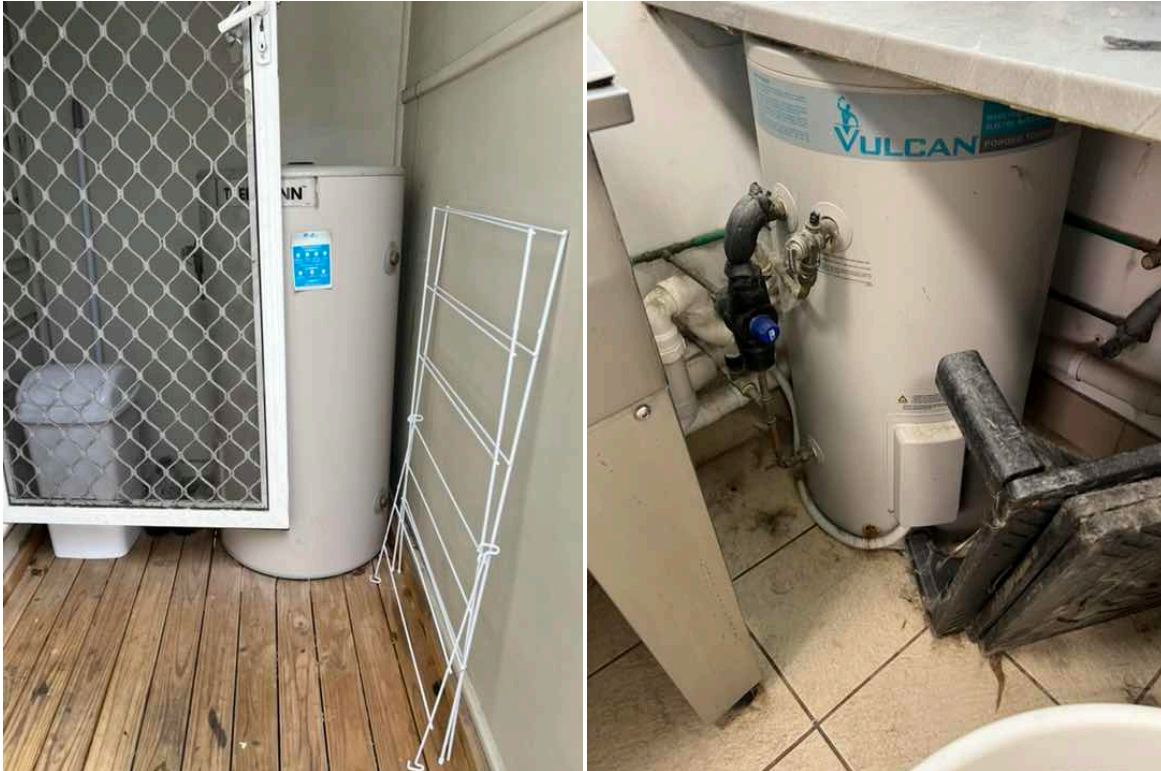
No - Divert hot water overflow away from the building perimeter

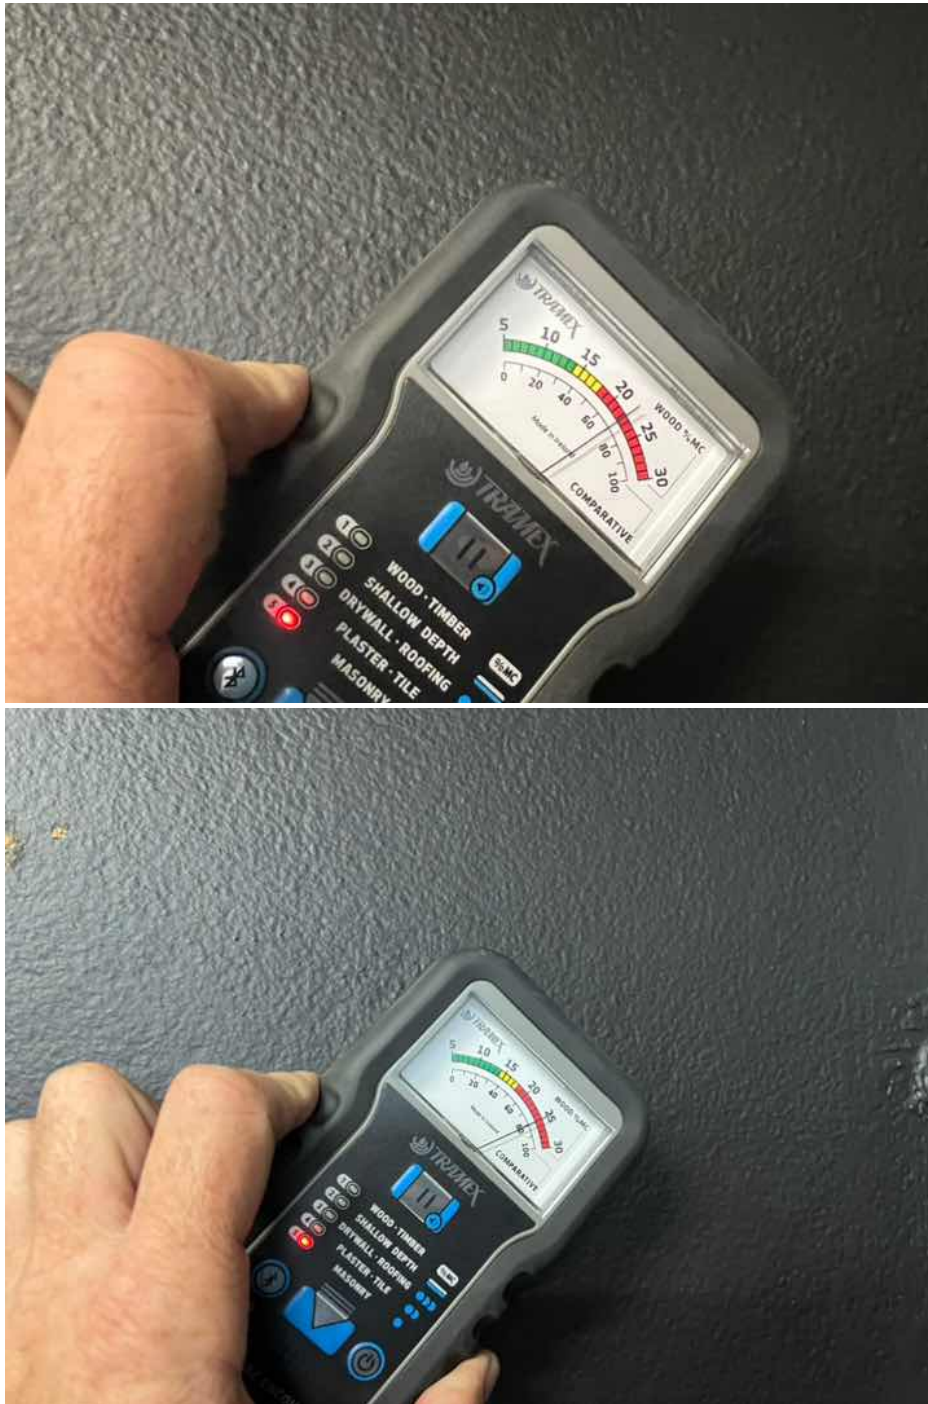
At the time of the inspection moisture readings were high.

If high moisture was reported then you must have a building expert investigate the moisture and its cause and determine the full extent of damage and the estimated cost of repairs prior to contracts becoming binding.

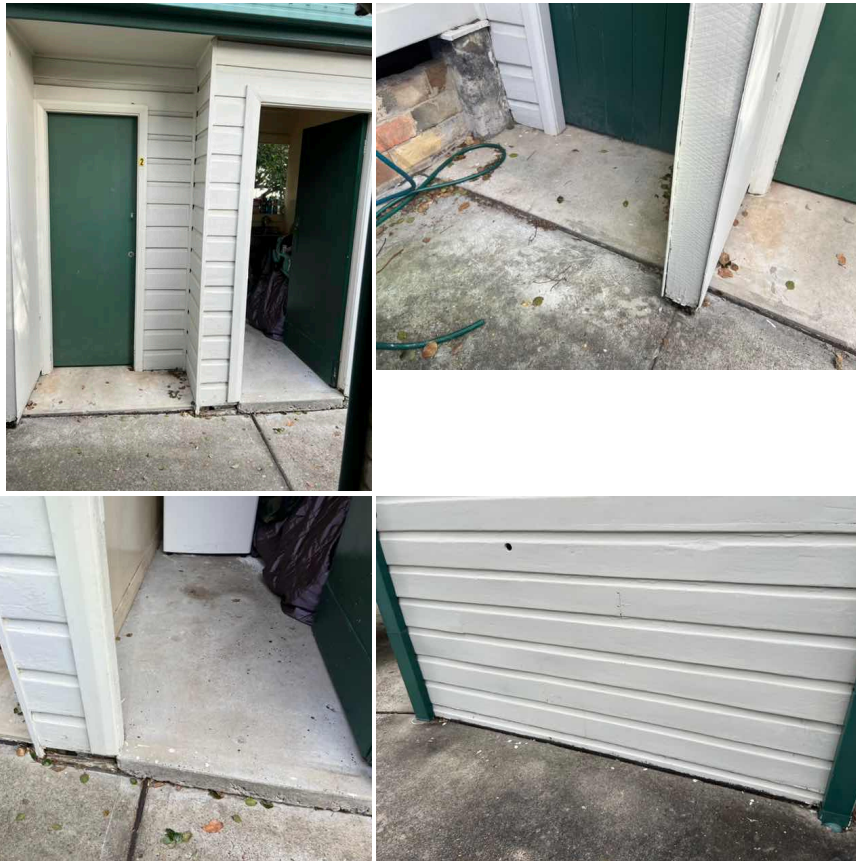
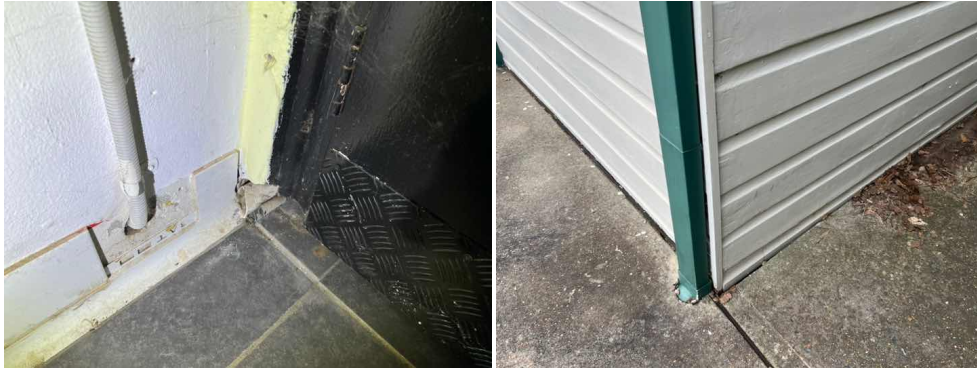
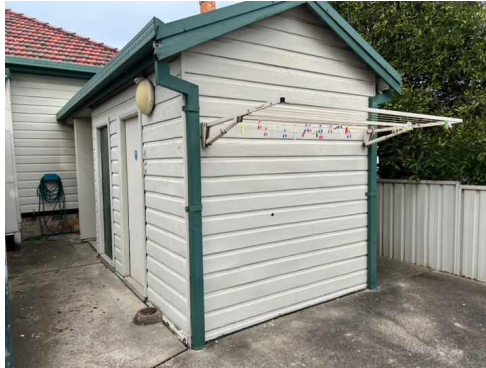
No. Slab edge should be exposed a minimum of 75mm.
